Manhole Inspection Summary

Manhole # S23M__032MH

Insp Date: **6/19/08 2:09 PM**

Location Address: **401 S Vincent St**

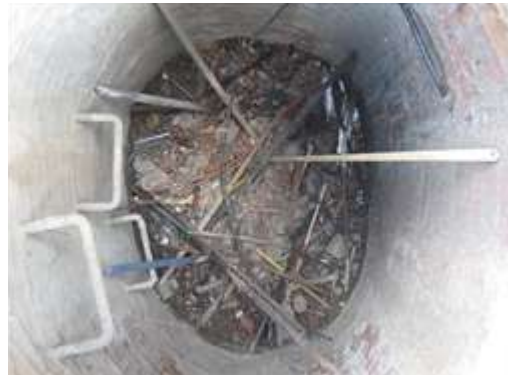
Top View

debris bench channel

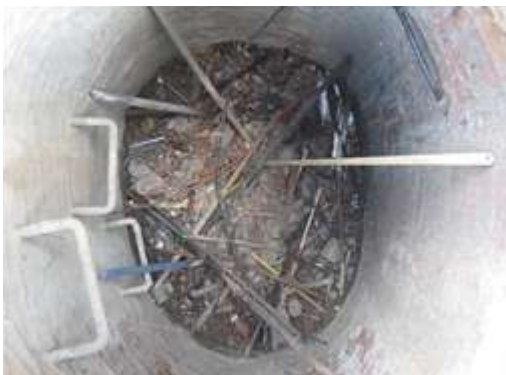
Defect 2

Condition: ☐ Sound ☐ Cracked ☐ Root Intrusion ☐ Deteriorated ☐ Leaks ☒ **Debris**

Channel debris

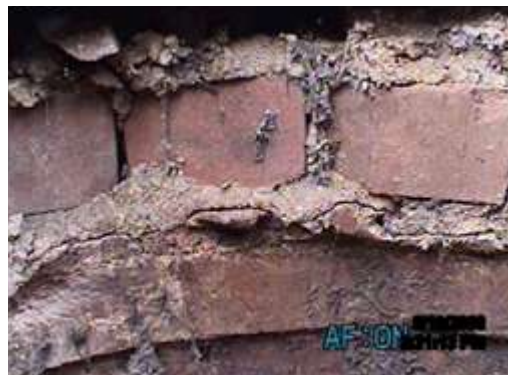
Defect 1

Condition: ☐ Sound ☒ **Cracked** ☐ Root Intrusion ☐ Loose Brick ☒ **Deteriorated**

chimney cracked & deteriorated

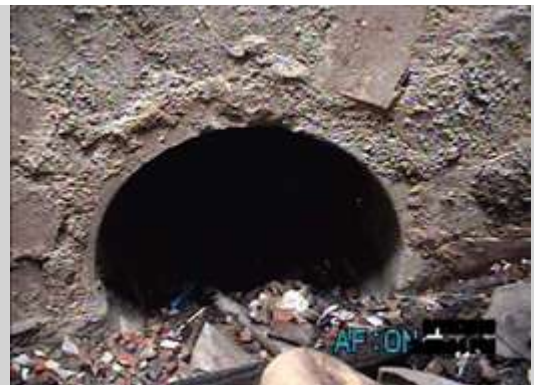
12 O'Clock Outflow

Deposits: ☐ None ☐ Mud ☐ Sludge ☒ **Debris** ☐ Grease

Silt Depth: **1** (in.) Deposits Extent: **Light**
